CORAL SPRINGS IMPROVEMENT DISTRICT  
10300 N.W. 11th Manor  
Coral Springs, FL 33071  
(954) 796-6669

PUMP INSPECTION FORM

CULVERT PIPE INSPECTION FORM

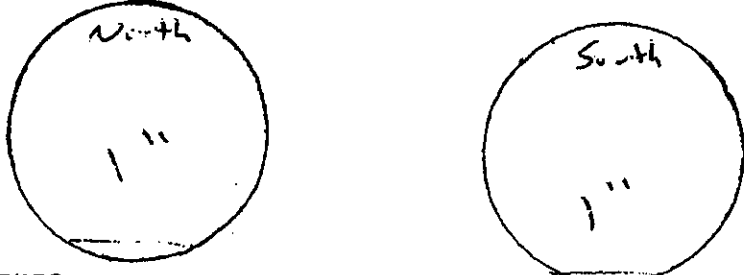
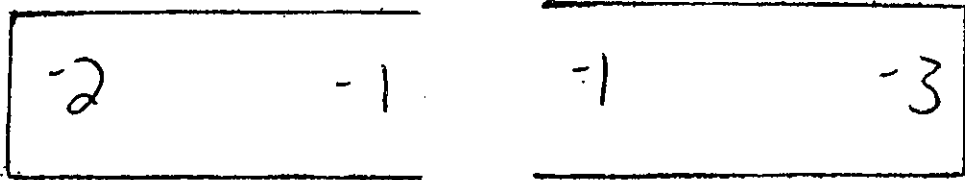
SITE#      STA. # 1

GENERAL CONDITION OF PIPE pipe joints in good condition. 2" gap in center pipe joint 45' in from N opening. No water coming thru, seal ok.

COMMENTS several <sup>ball</sup> size rocks in North opening of pipes. scattered small 2-3" stones sprinkled thru pipe.

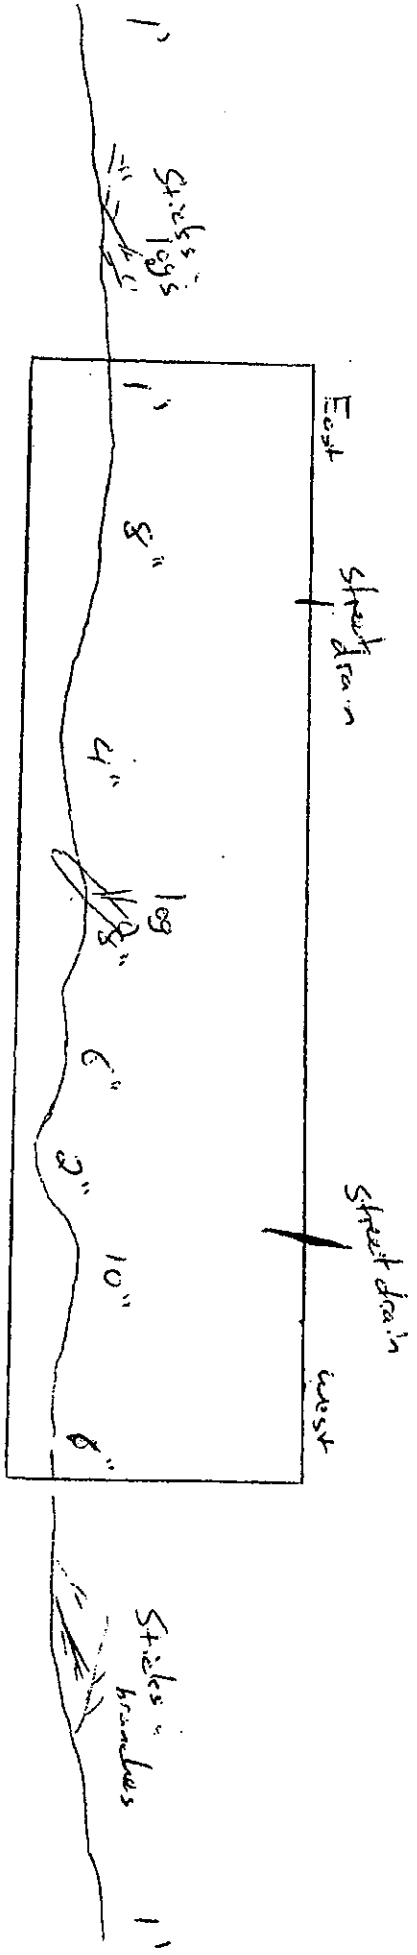
SITE# E-3

GENERAL CONDITION OF PIPE pipe, joints, drains all in good condition.

COMMENTS 2"-1' of silt, branches, debris, organics in pipe; outfalls.  
Large log in center of pipe

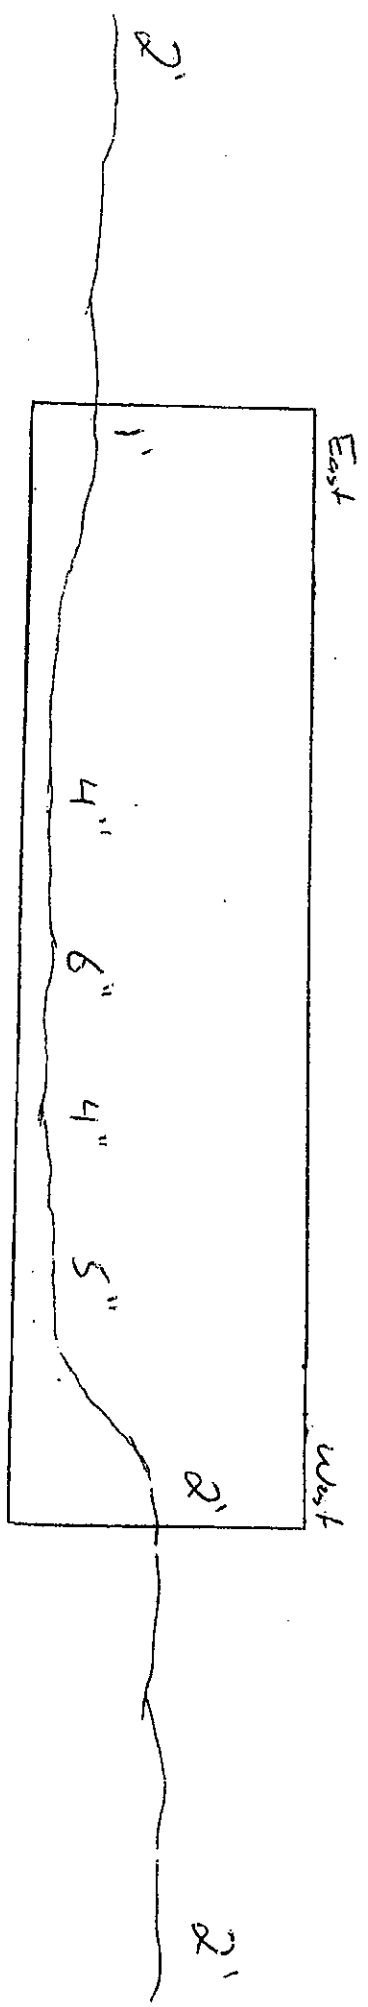
Site # E-4

GENERAL CONDITION OF PIPE pipe, joints, & drains all in good condition

COMMENTS Silt & organics concentrated @ pipe openings & outfalls. 2-6" of silt & organics thru majority of pipe.

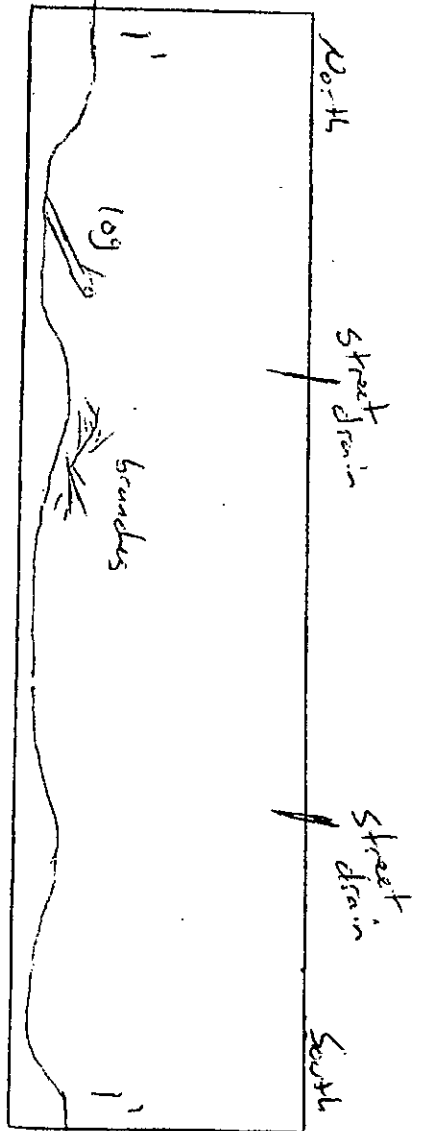
Site # E-5

GENERAL CONDITION OF PIPE Pipe diameter measured 60". North opening had a 4' x 3 1/2' square cut on top. The rest of the pipe, joints, & drains were in good condition.

COMMENTS Majority of material @ pipe openings @ street drains. Material consists of sand, silt, gravel, organics, & debris. Large log 25' in from North opening.

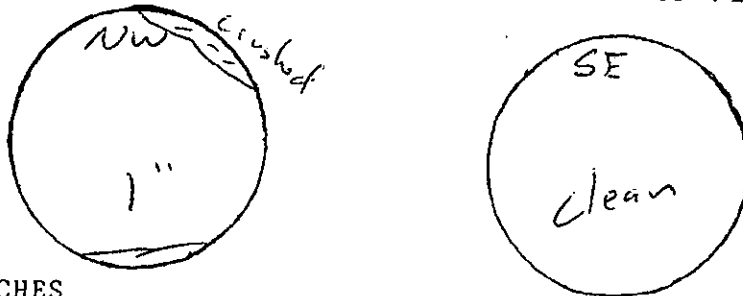
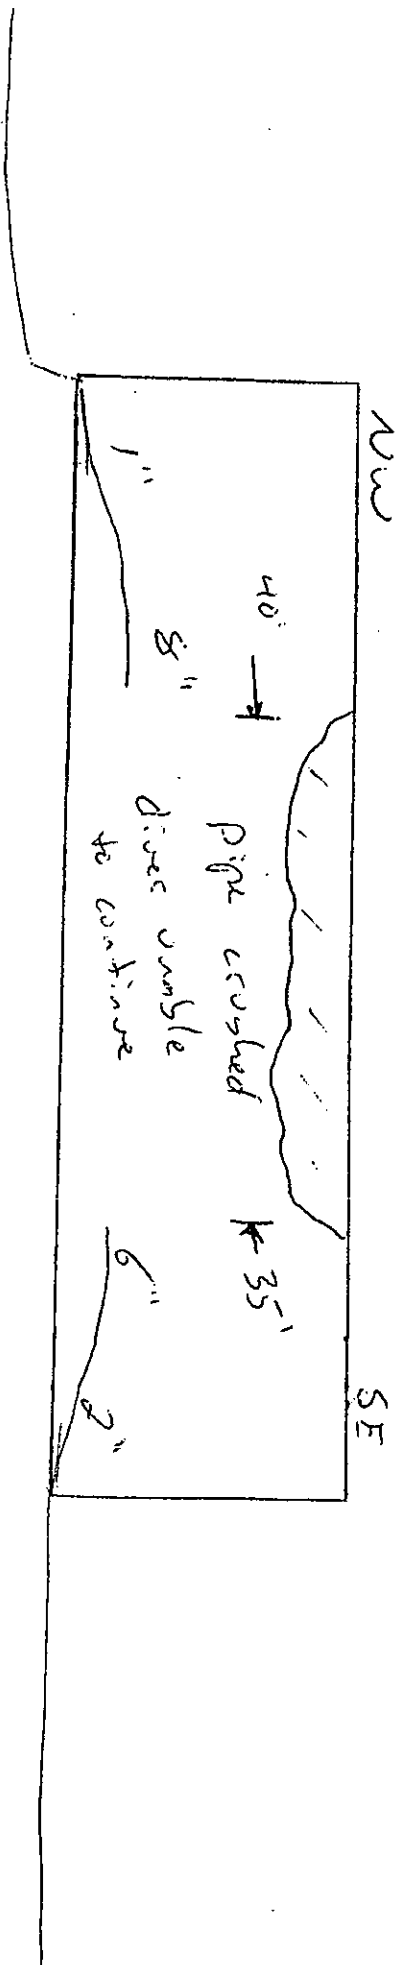
SITE# E-20

GENERAL CONDITION OF PIPE Pipe interior covered between 40' from NW opening : 35' from SE opening.

COMMENTS 1" to 8" of small shells, pea gravel, sand, & silt in pipe. Diver unable to inspect entire pipe because of interior damage

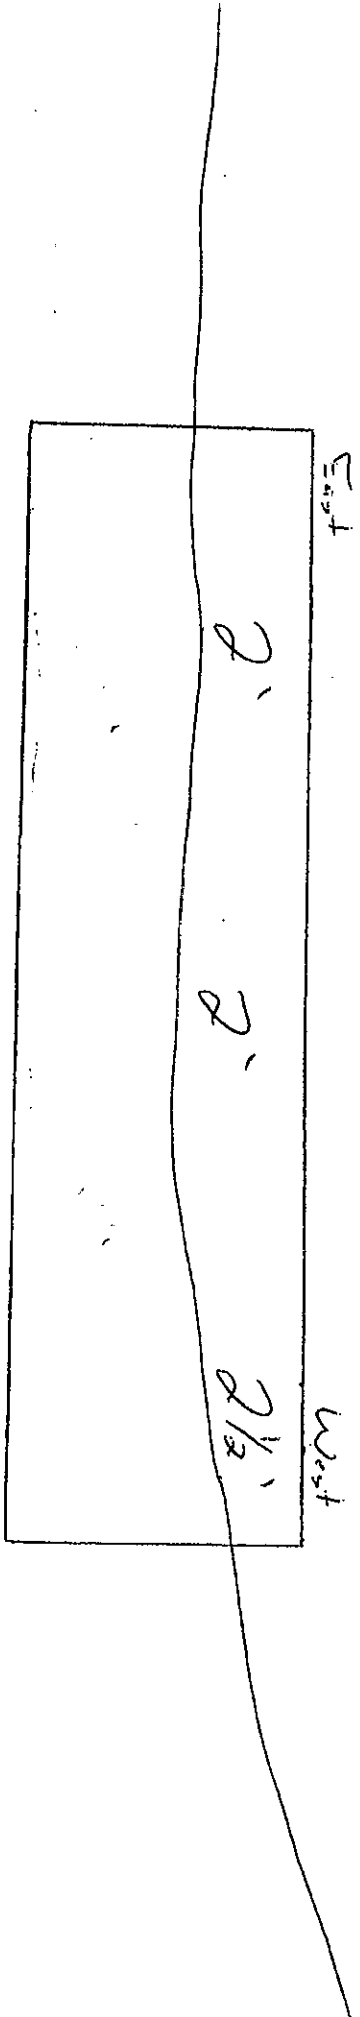
Site # E-22

GENERAL CONDITION OF PIPE pipe joints, & interior in good condition

COMMENTS 2' of silt & leaves in pipe

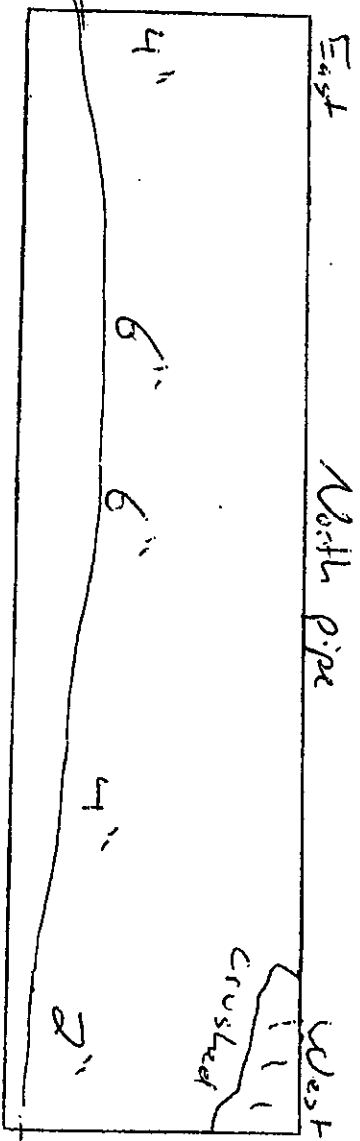
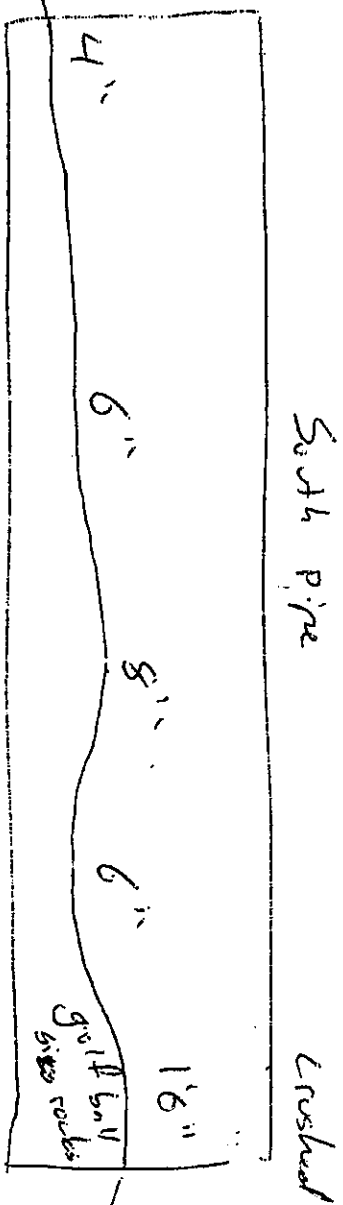
SITE# W-3

GENERAL CONDITION OF PIPE West opening of North pipe is crushed on top 2'. The rest of the pipe, joints, & drains are in good condition

COMMENTS 1 1/2' of golf ball size rock @ W opening of North pipe. Pipe interior contains pea gravel, silt, leaves, & hard packed mud.

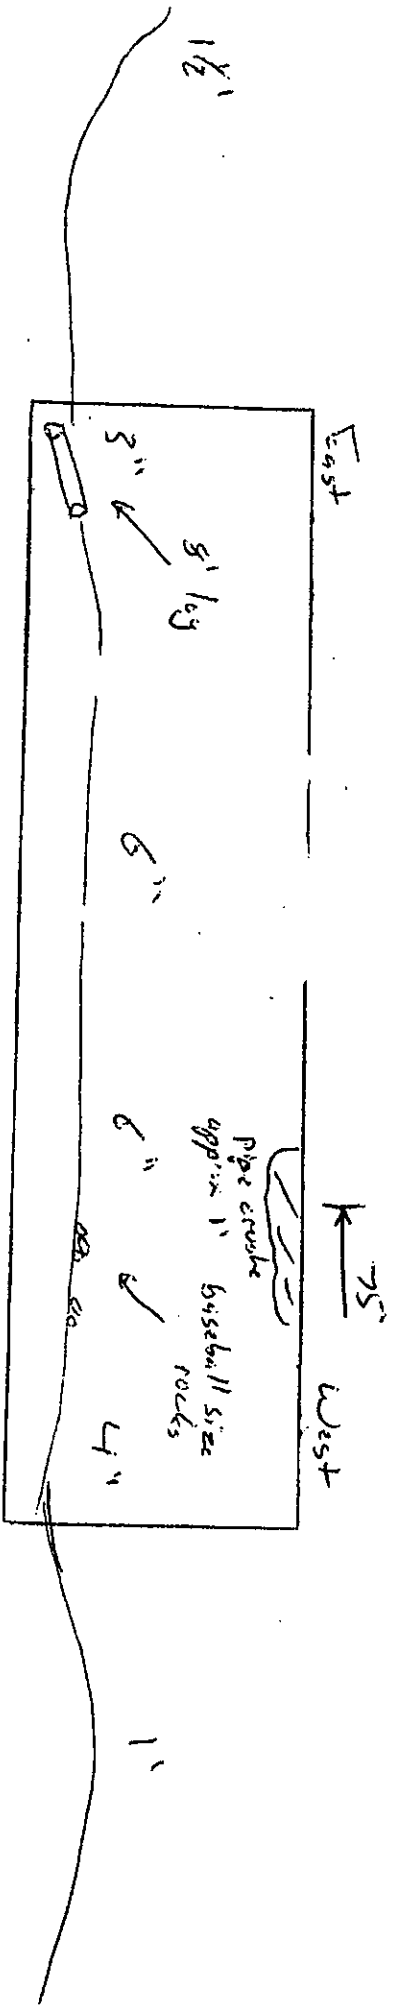
Site # W-4

GENERAL CONDITION OF PIPE West opening severely clogged on side. The rest of the pipe, joints, & drains are in good condition.  
Minor clog in pipe 75' in from W opening

COMMENTS 4" to 6" of pea gravel, twigs, & debris in pipe. At  
Opening there are several 4"-5" rocks, a 2x4, & 8' log.

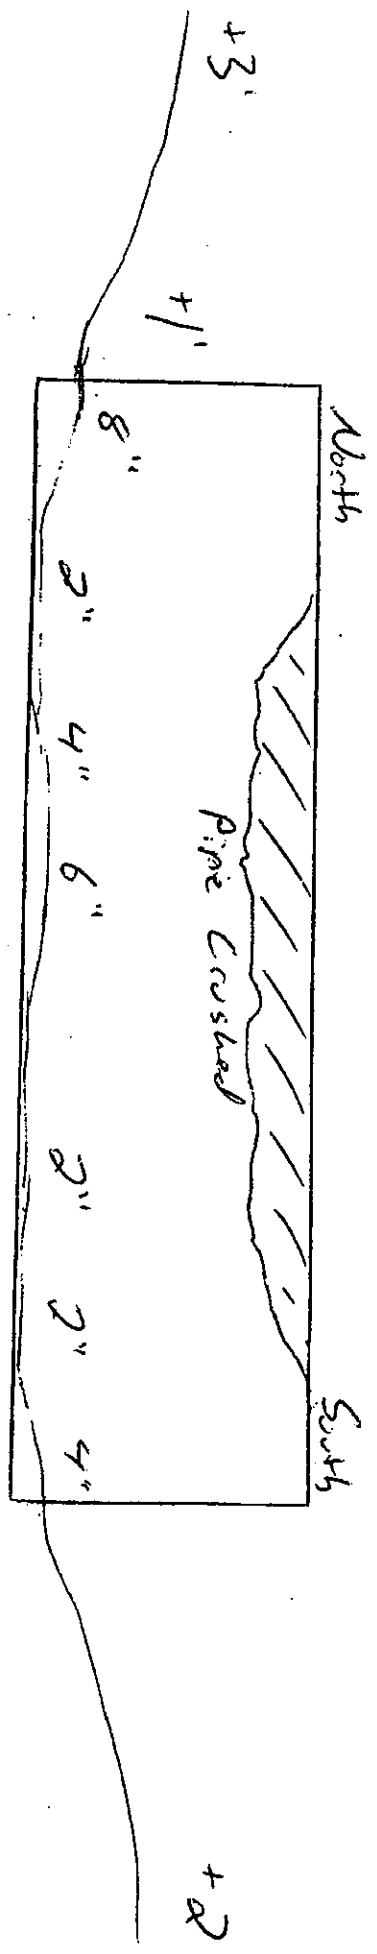
Site # W-5

GENERAL CONDITION OF PIPE majority of pipe covered 1' to 1 1/2' inside  
from 35' inside South opening to 50' inside North opening  
Joints in good condition.

COMMENTS 2" to 8" pea gravel, sand silt, leaves, debris inside pipe.  
Branches & tree debris littering North outfall.

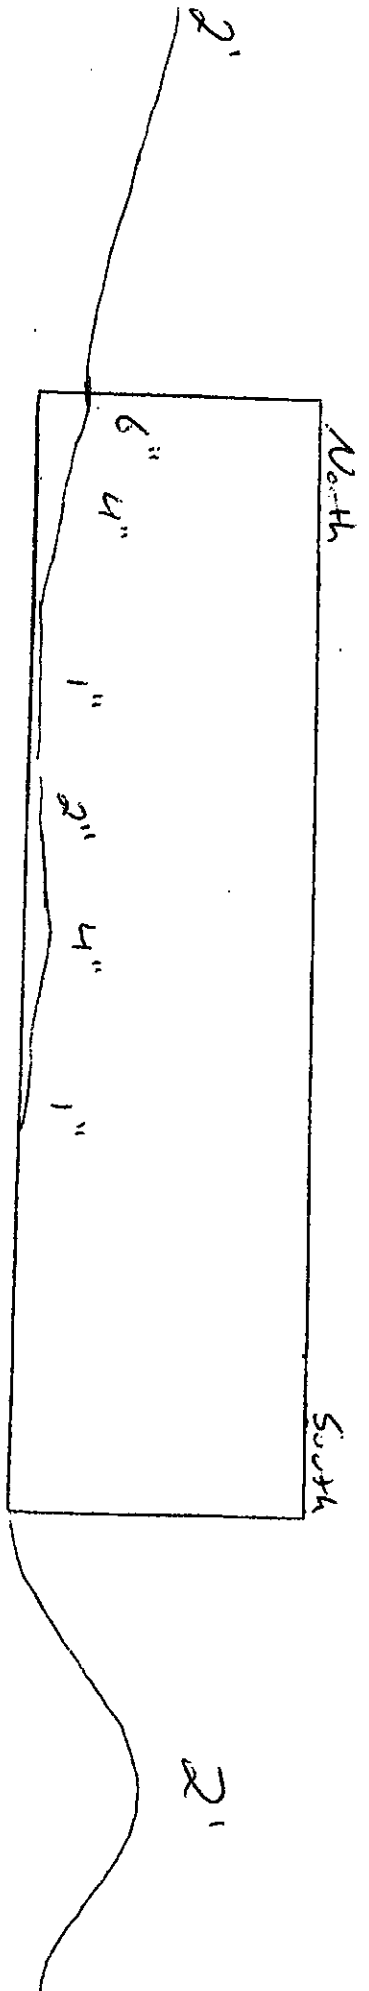
Site # W-7

COMMENTS 6" pea gravel @ North opening then ranges from 1' to 4" of pea gravel, silt, & leaves inside pipe. South end clear. Pipe patches @ 25' in ; 90' in holding ok.

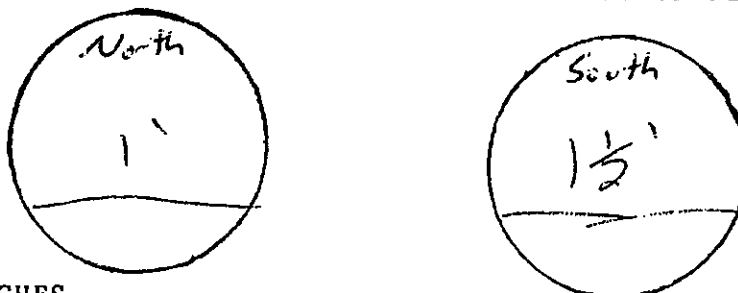
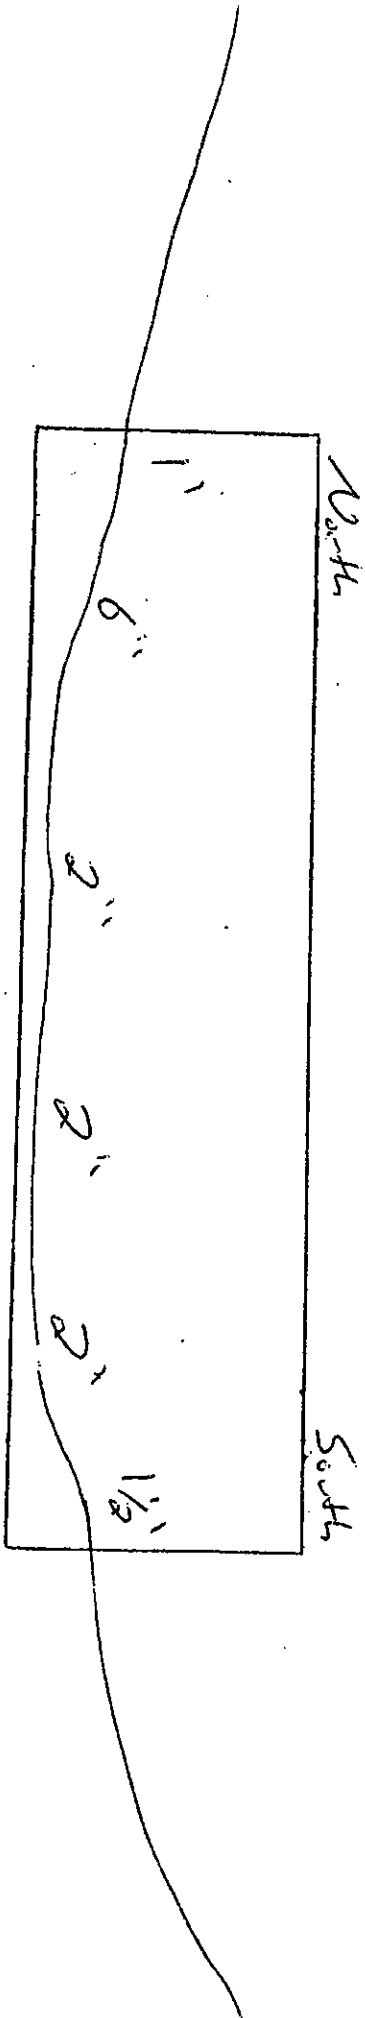
Site # W-11

COMMENTS sand, rocks, & organics piled @ both openings.  
2" of silt & sand inside pipe.

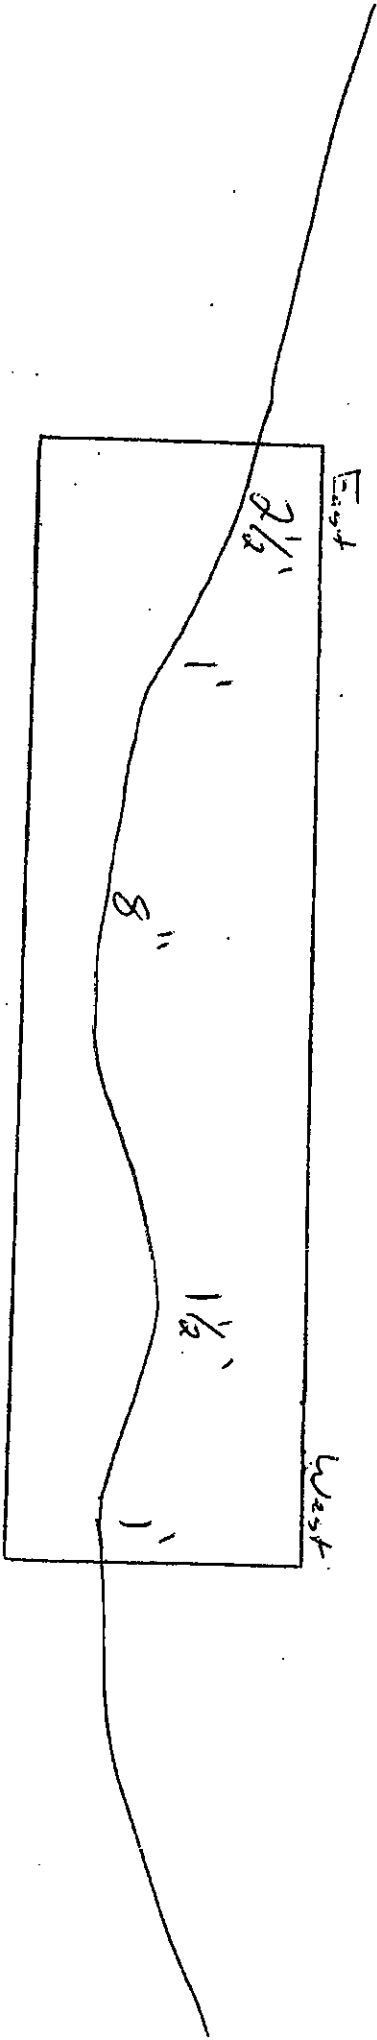
Site # W-12

GENERAL CONDITION OF PIPE E opening dented & ripped. The rest of the pipe, joints, & drains are in good condition

COMMENTS E end of pipe 90% plugged. 8" to 1 1/2' of leaves, silt, & branches in pipe.

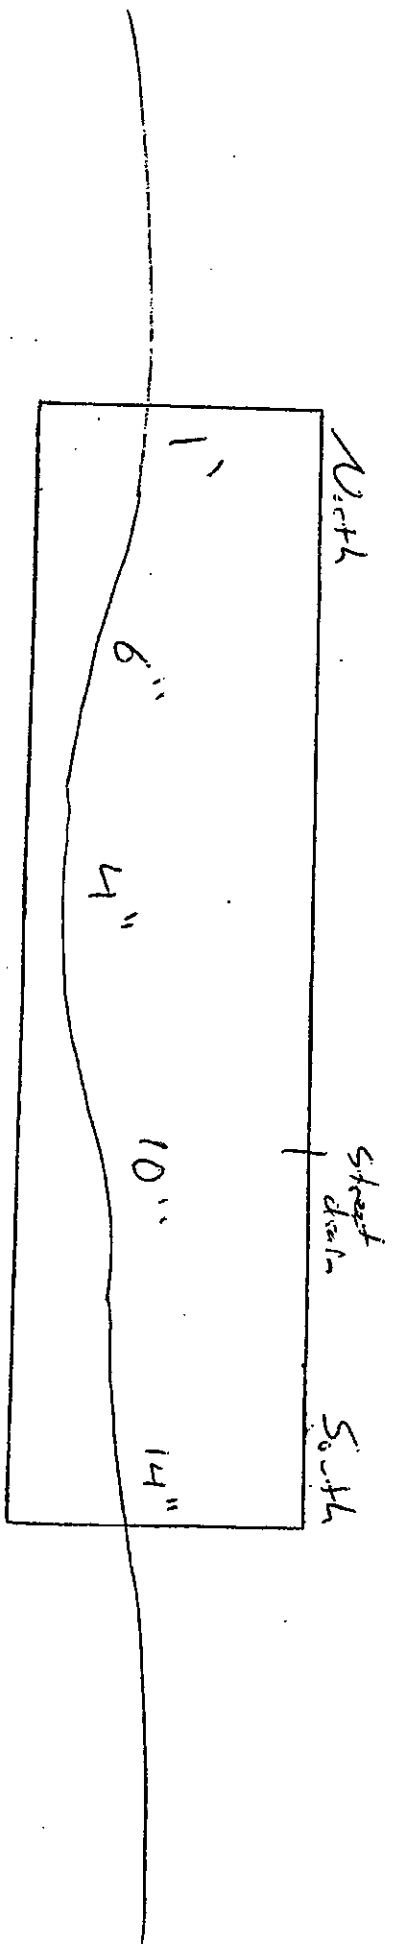
Site # W-13

COMMENTS 4" to 1" of silt & leaves in pipe

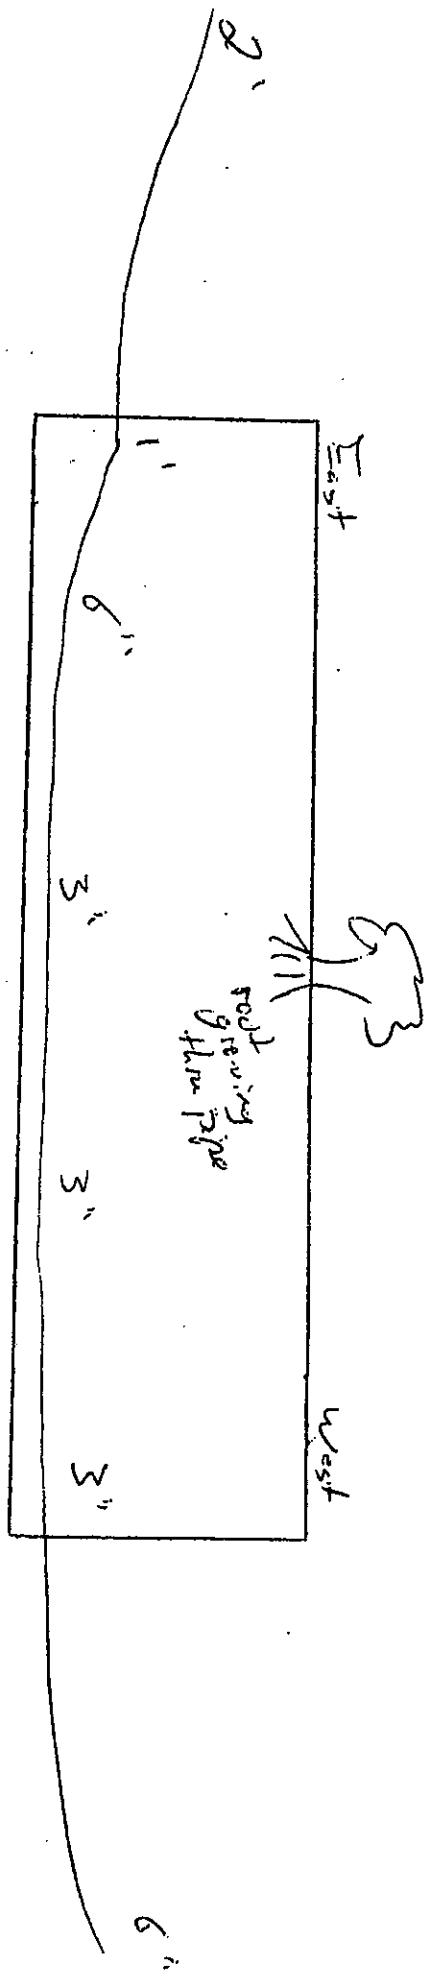
Site # W-15

GENERAL CONDITION OF PIPE tree root growing thru pipe approx half way thru (middle pipe). The rest of the pipe joints & drains are in good condition.

COMMENTS 2'-3" of muck inside pipe, 1' of muck @ East  
entrance

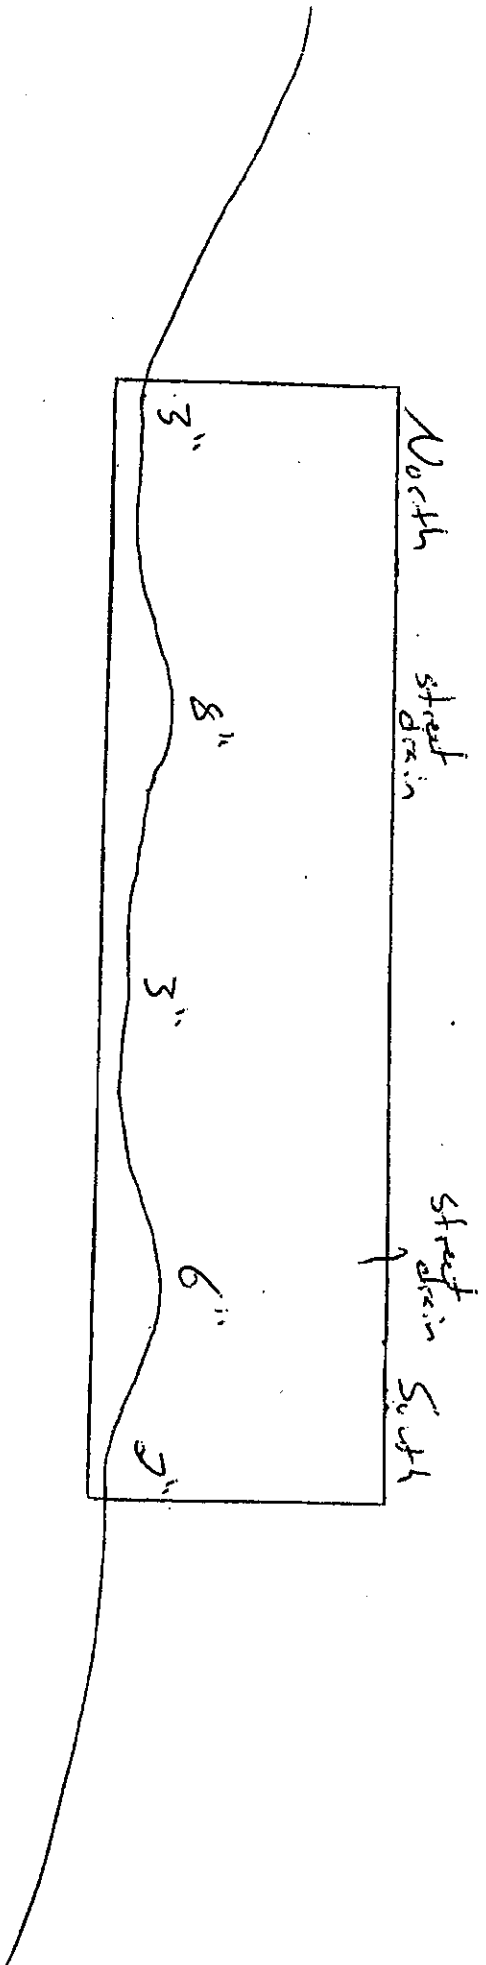
Site # W-16

COMMENTS 2" to 8" of sand, fine gravel, & organics in pipe.  
Mostly concentrated @ street drains

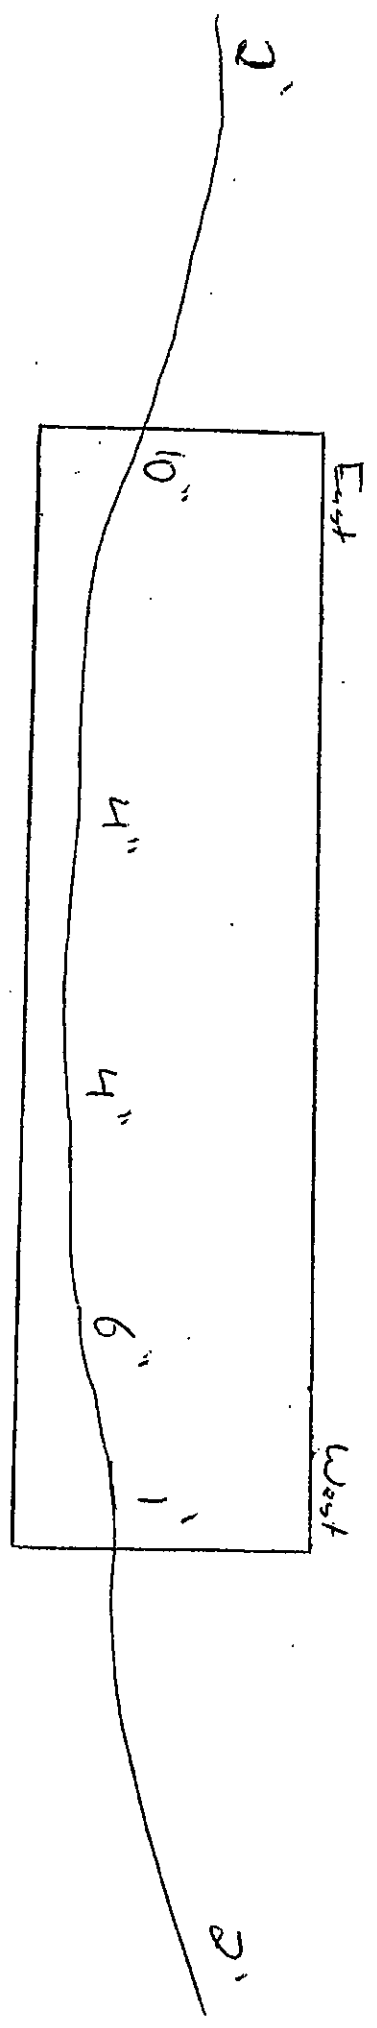
Site # W-17

COMMENTS 4' to 1' of mud & organics in pipe. Mound of material @ both pipe entrances

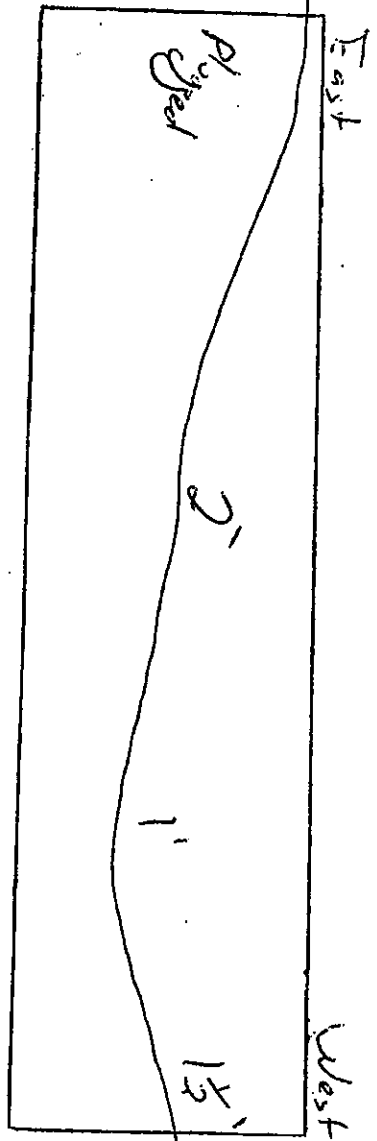
Site # W-20

COMMENTS E opening 90% plugged with muck; leaves, pipe interior has 1" to 2 1/2" of muck, organics, & sand

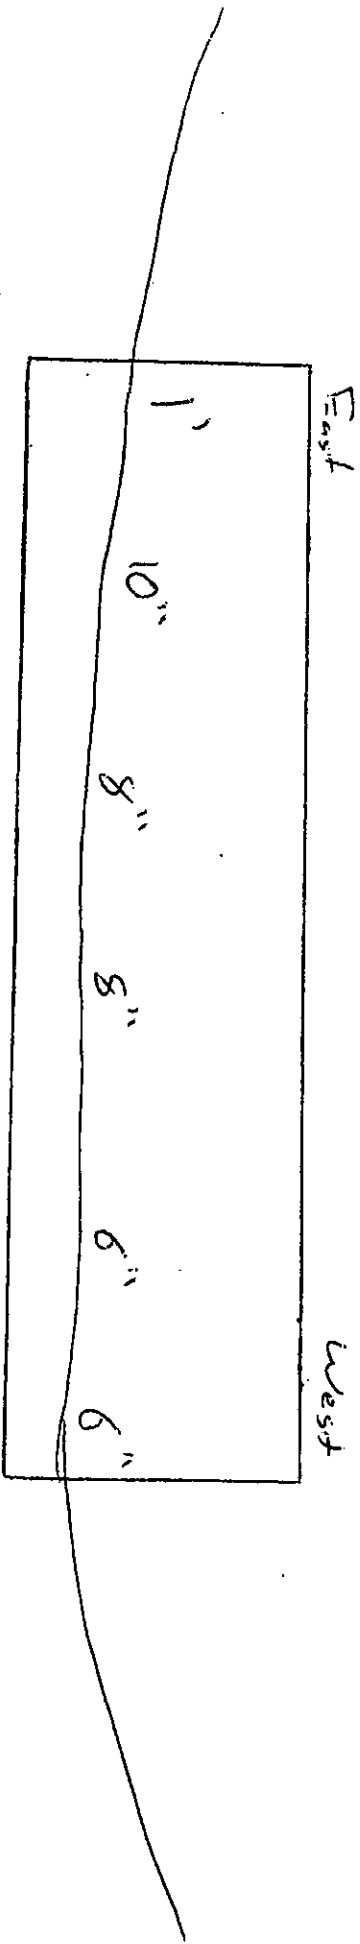
Site # W-23

COMMENTS 6" to 1' of sand, gravel, muck & debris in pipe

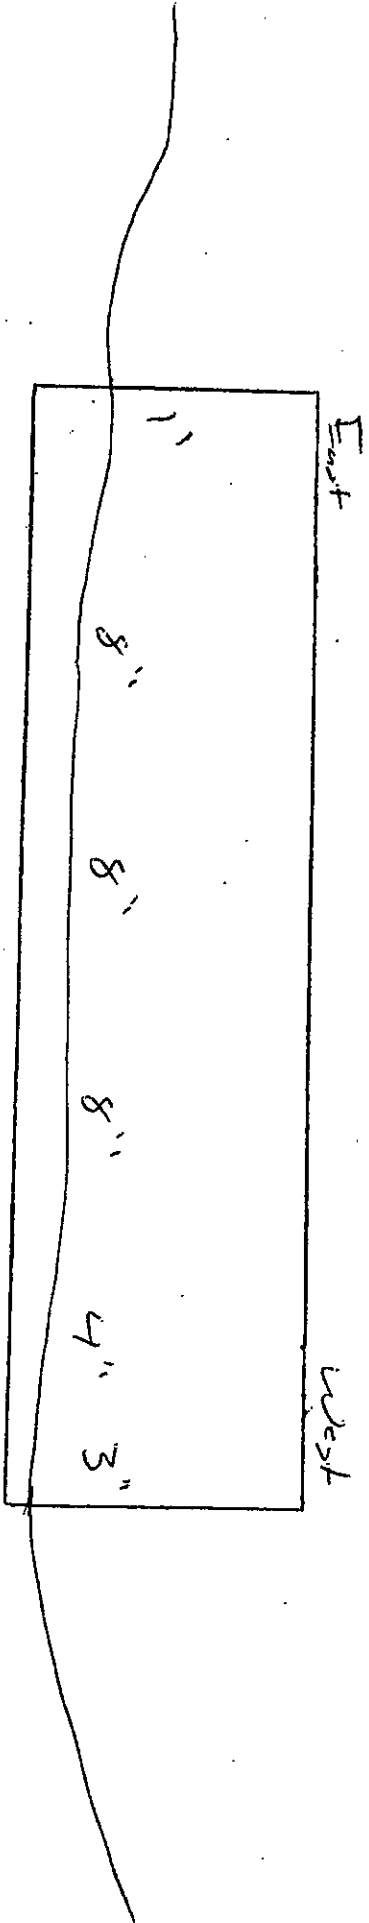
Site # W-27

GENERAL CONDITION OF PIPE East opening is clogged 3" @ 11 o'clock position. The rest of the pipe, joints, & drains are in good condition

COMMENTS 3" x 1" of muck, gravel, & debris in pipe
